# Manhole Inspection Summary

Manhole # S21A\_\_021MH

Insp Date: **9/17/07 10:28 AM**

**Location** Address: **1711 EDMONDSON AVE**

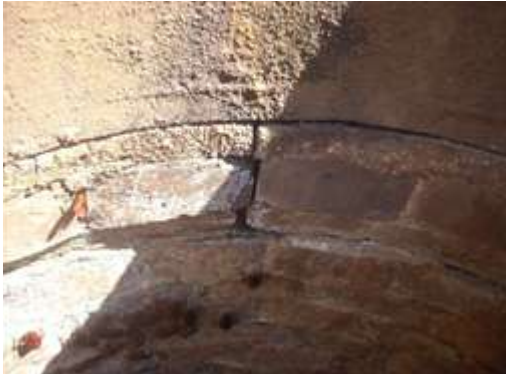
Defect 1

Condition: ☐ Sound ☐ Cracked ☐ Root Intrusion ☐ Loose Brick ☒ **Deteriorated**

DETERIORATED CHIMNEY

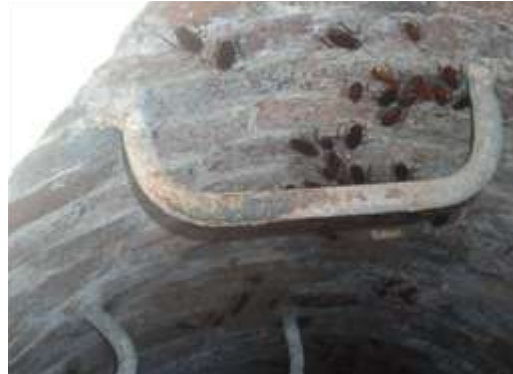
Defect 2

Count: **5** Missing: **0** ☒ **Corroded**

CORRODED STEP

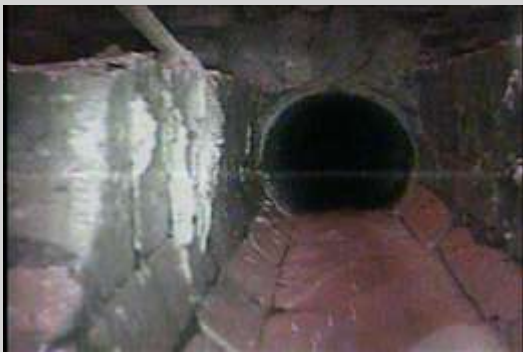
12 O'Clock Outflow

Pipe Height: **8.4** (in.) Rod and Bar (Angled)  
Pipe Material: **Clay** ☐ Pipe Lined  
Invert Depth: **9.62** (ft.) Flow Characteristics: **Fast**  
Deposits: ☒ None ☐ Mud ☐ Sludge ☐ **Debris** ☐ Grease  
Silt Depth: (in.) Deposits Extent:  
Infiltration: **None** Pipe Seal Cond: **Sound**

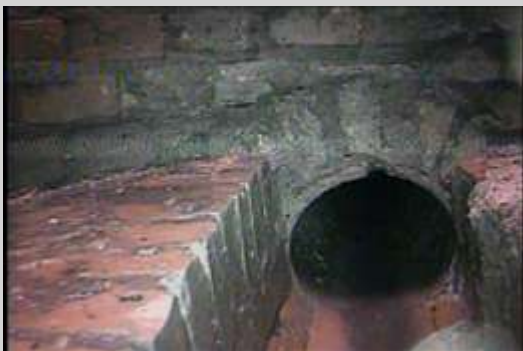
6 O'Clock Inflow

Pipe Height: **7.2** (in.) Rod and Bar (Angled)  
Pipe Material: **Clay** ☐ Pipe Lined  
Invert Depth: **9.48** (ft.) Flow Characteristics: **Fast**  
Deposits: ☒ None ☐ Mud ☐ Sludge ☐ **Debris** ☐ Grease  
Silt Depth: (in.) Deposits Extent:  
Infiltration: **None** Pipe Seal Cond: **Broken**

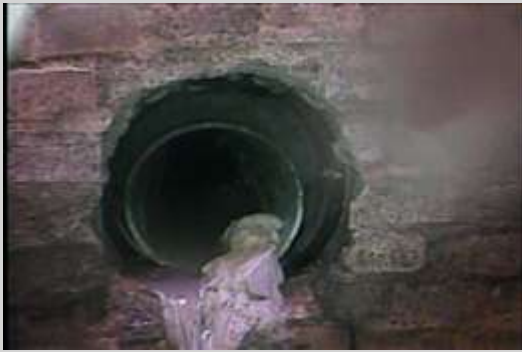
9 O'Clock Inflow

DETERIORATED CHIMNEY

Deposits: ☐ None ☐ Mud ☐ Sludge ☒ **Debris** ☐ Grease

Silt Depth: **4** (in.) Deposits Extent: **Heavy**

Drop Condition: **Partly Clogged**
